NAVISTAR, INC

DEFECT INFORMATION REPORT

REPORT ID: 15-I6-12000563_01
Revision.: -
Ref. Invest.: -
Ref. AFC: -
Ref. VERR: -

DATE : March 04, 2015

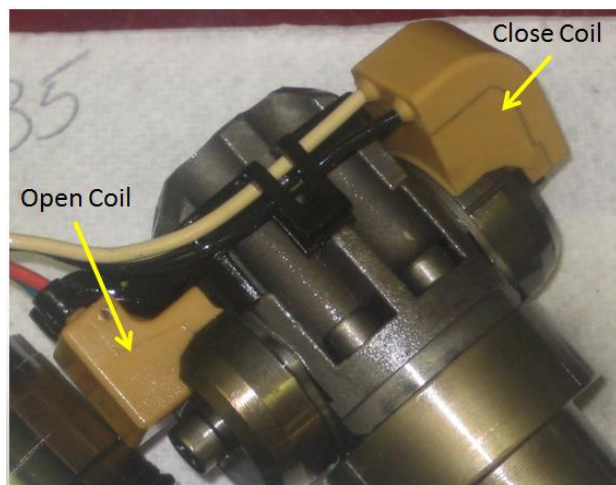
This report addresses a design defect in the electronic / hydraulic unit injector. The injector contains an “open” coil and “close” coil as seen below. The coils move a spool valve back and forth, which admits high pressure oil to an intensifier piston, causing a fuel injection event.

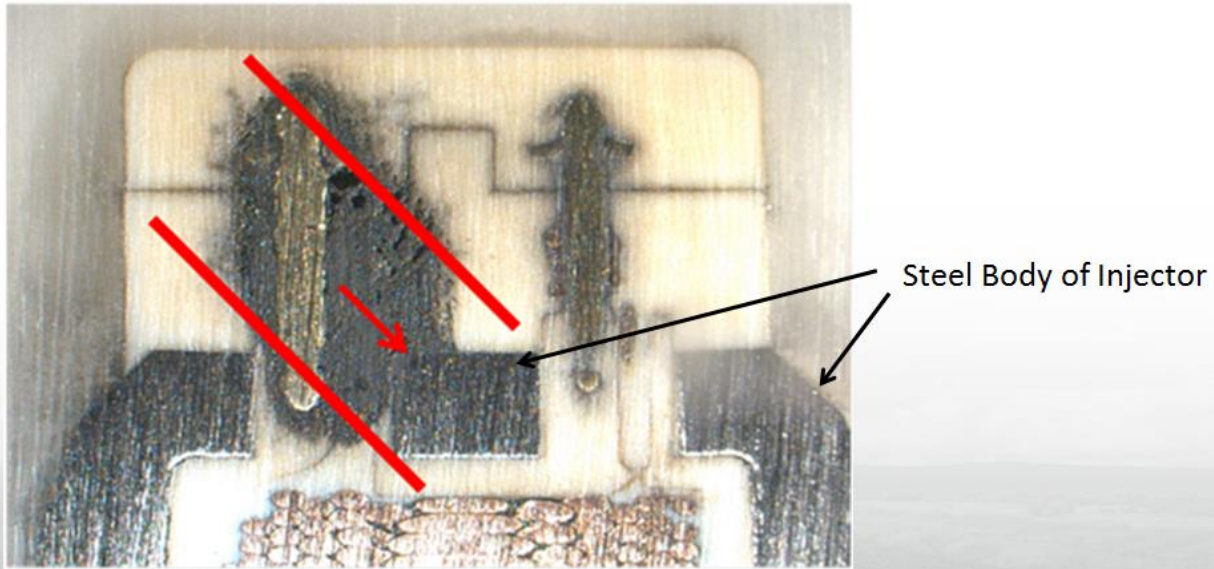
Both coils have a “high side” and “low side” solder connection which attaches the injector wiring to the coils. The “high side” solder joint in the close coil will occasionally increase in resistance. This may be due to manufacturing issues or contamination from engine oil. Once the resistance increases, localized Joule heating causes melted solder and copper wire to create a short circuit to the injector body (ground). This is commonly referred to as a “HiPot” failure. Due to the control system design, a HiPot failure will disable 3 injectors and set appropriate diagnostic codes.

Below is a sectioned close coil illustrating a typical HiPot failure. The charred area between the red lines is where the solder has shorted the terminal to the injector body.

High side pin of injector coil becomes shorted to ground.

This failure mode increased from less than 1% of injector failures to ~ 45% when a design change to the fuel pressure/oil pressure intensification ratio was made. The ratio was increased from 7.6 / 1 to 10 / 1. This change required additional injector modifications to allow for higher oil demands including a longer close coil energize duration. The duration was increased from 1.0 mS to 1.5 mS for all engine operation even though it was only required for high fuel flow and / or extreme cold or hot oil operation.

A software modification has been designed and calibrated which will reduce the close coil on time to 1.2 mS during engine operation when 1.5 mS is not required while automatically returning to 1.5 mS when required.

Navistar intends to perform a voluntary emissions recall to reflash ECM's with calibrations containing updated close coil on time software. Due to the number of engines the recall will be performed in stages.

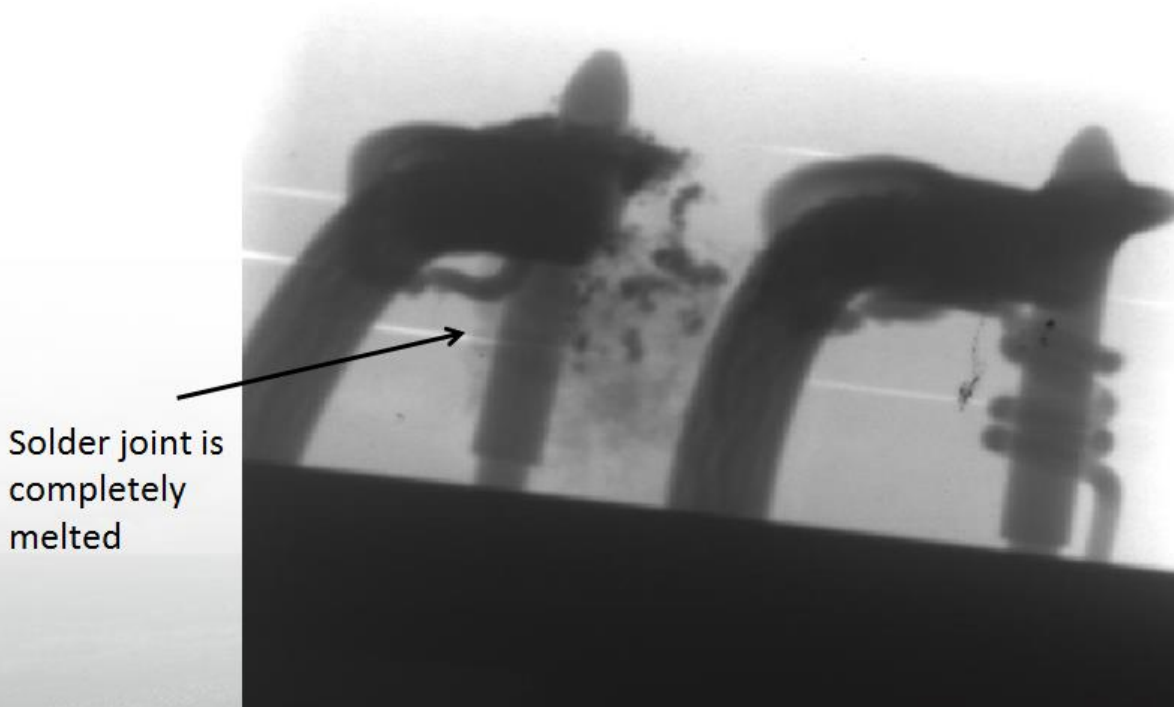
Below is an x-ray of another failed close coil.

Solder joint is completely melted

- Wires are completely gone
